## Appendix G

# NEW and REDEVELOPMENT CONTROL MEASURES

## 2009 SCVURPPP Site Design Awards

### Summary of Award-Winning Projects

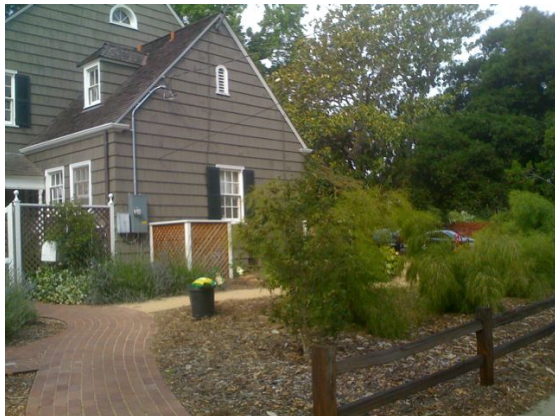
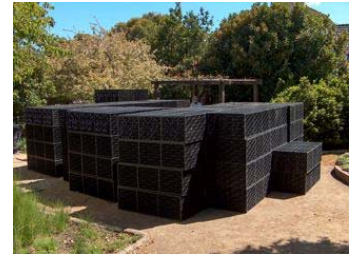
#### Rosenberg Residence Rainwater Cistern, Palo Alto (Winner: Private Project Small Residential)

This single-family residential property in Palo Alto installed a 14,000-gallon, underground rainwater cistern that harvests stormwater runoff from the roof of the residence and site hardscaping for reuse as landscape irrigation water. The cistern is constructed using plastic modular units buried underground within a watertight liner.

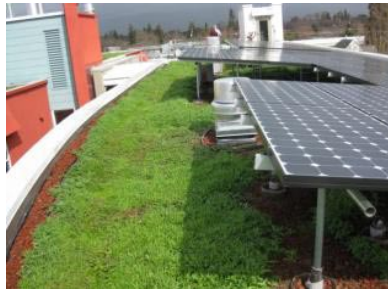
#### Casa Feliz Studios, San Jose (Winner: Private Project Large Residential)

Casa Feliz Studios is a 4-story, 25,000 square foot affordable housing complex located on a one-third acre infill site near downtown San Jose. The project features 5,375 square feet of green roof area that can retain 80% of the rain that falls on them. The roofs were landscaped with drought tolerant, native plants that require no irrigation beyond that which was required to establish the plants.

The two largest sections of roof are planted with a mixture of organically grown, annual and

perennial grasses and wildflower species designed to attract local wildlife, including the endangered

Bay Checkerspot butterfly. Also included in this area is a 16-kilowatt photovoltaic array.

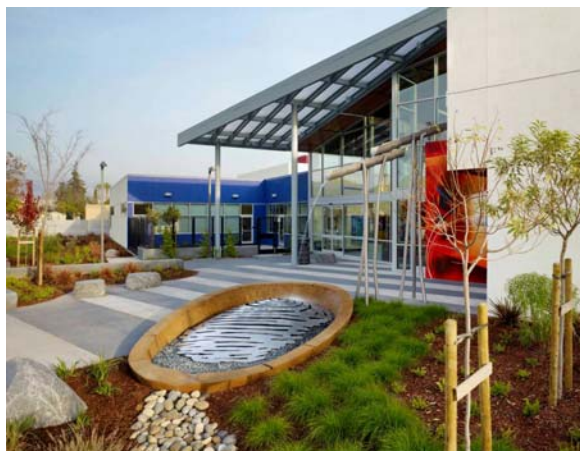
### **Roosevelt Community Center, San Jose (Winner: Public Project)**

Roosevelt Community Center is a 91,900 square foot facility located adjacent to Coyote Creek in San Jose. Roosevelt Community Center has stormwater best management practices (BMPs) that were designed with the goal of being functional, as well as informing the public on how the City of San José is utilizing stormwater control measures to improve water quality and decrease stormwater runoff.

Coordination with the City Department of Cultural Affairs' Public Art Program led to the design of visible, functional, and aesthetic stormwater treatment devices, such as a thumbprint rock pool filter and vertical rock treatment system.
